## PROBLEM

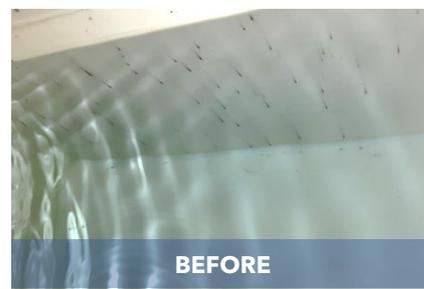
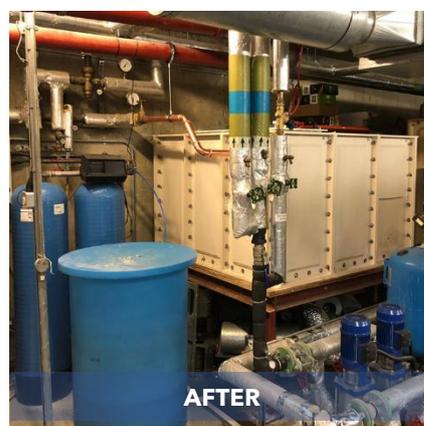
Primary Water Solutions attended site and performed a thorough investigation into the water hygiene management programme and performed an inspection of the cold water storage tank and produced a report detailing their findings and recommendations. Tank appearance looked poor due to the gel coat failing, leading to osmotic blistering and black spore mould growth which are the black spots on the tank walls.

Primary Water Solutions recommended two options - replace the tank with a direct replacement due to calculated usage or provide a WRAS approved solvent free polyurethane coating. Both options would be fit for purpose and would offer a ten year guarantee and the options were discussed in detail - the client decided to replace the water tank rather than coat on this occasion in order to ensure the unit was installed and commissioned within the two day timeframe - Primary Water Solutions managed to ensure customer satisfaction and provide a fit for purpose replacement cold water storage tank and ensure no disruption to the buildings water supply.
